Manhole Inspection Summary

Manhole # S31UU1017MH

Insp Date: **1/16/07 5:38 PM**

Location Address: **107 SAINT ALBANS WAY**

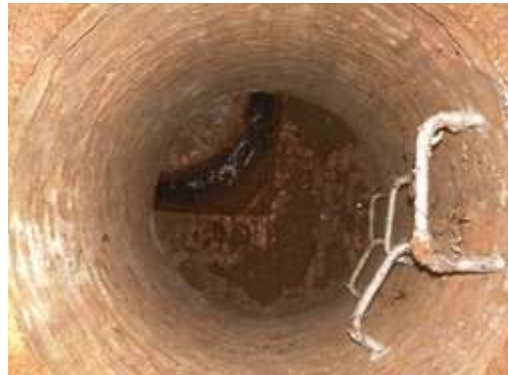
Top View

Bench ☒ Exists Material: **Brick** ☐ Parged ☒ **Debris** (not Condition related)

Bench debris.

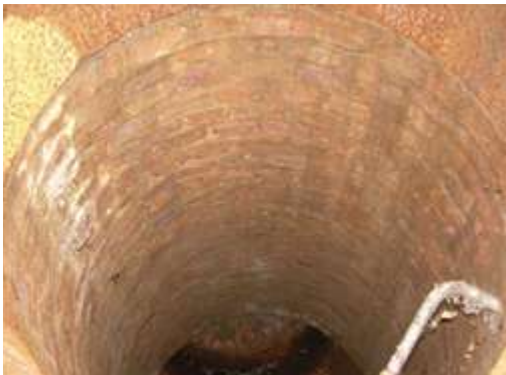
Defect

Infiltration: ☐ None ☒ **Joint** ☐ Cracks ☐ Mortar ☐ Roots ☒ **Wall**

Adjustment infiltration - other side.

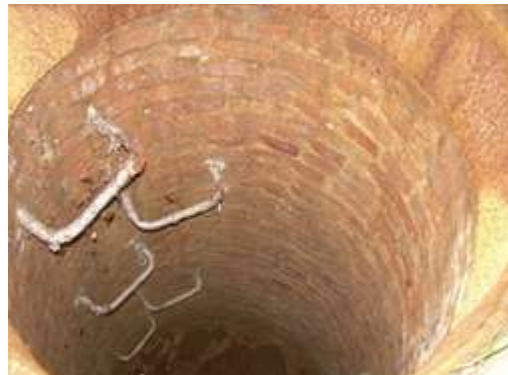
Defect

Adjustment infiltration.

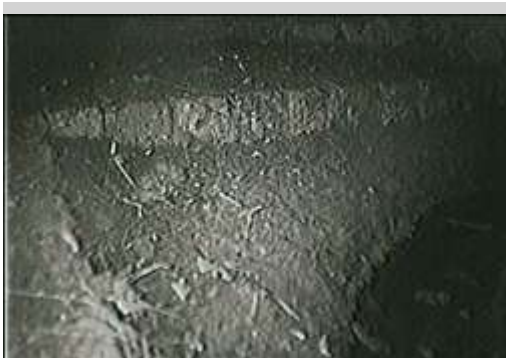
Defect

Condition: ☐ Sound ☐ Cracked ☒ **Root Intrusion** ☐ Deteriorated ☐ Leaks ☐ Debris

Channel root intrusion.

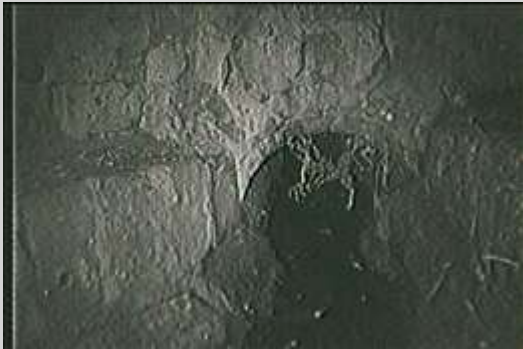
8 in. Circular Gravity Sewer Pipe Out @ 12 O'Clock

Infiltration: **Evidence** Pipe Seal Cond: **Roots**

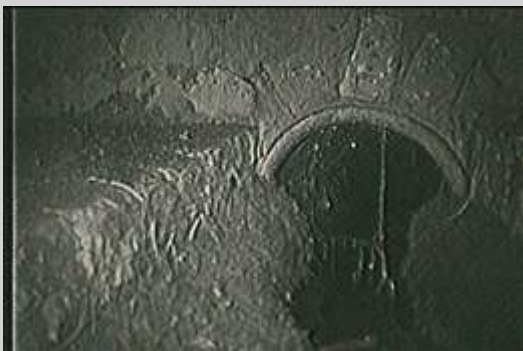
8 in. Circular Gravity Sewer Pipe In @ 9 O'Clock

Channel root intrusion.

Infiltration: **Evidence** Pipe Seal Cond: **Roots**
